KF155.81U/EN/03/2022

Removal / Installation recommendations

<p>RENAULT: LAGUNA II (BGO), LAGUNA II Phase 2, SCENIC II</p>	<p>OE reference 7701472838D, 7701713008, 8200655249D, 8200367094D</p>
--	--

IDENTIFICATION OF BRAKE DISC HUB KIT KF155.81U

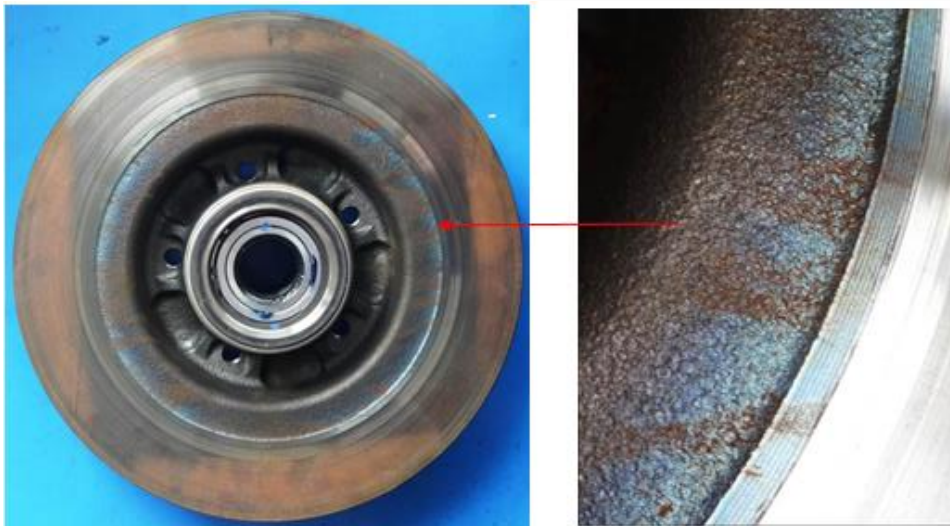
Rear brake disc hub over heating

If the calliper or parking brake are not releasing correctly it can cause abnormally high temperatures in the disc hub , this high heat often leads to bearing failure and disc damage.

Check that the brake calliper and parking brake are operating correctly

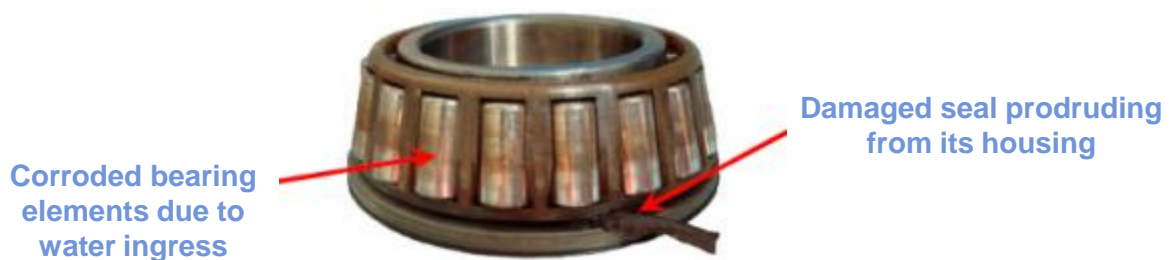
Brake disc hub incorrectly fitted on to the stub axle

During the installation process it is possible to push the brake disc hub on to the stub axle at an angle.

When the brake disc hub is not pushed on squarely there is a possibility that the inner ring of the bearing can be pushed out of its locking ring. When the inner is pushed out of its locking ring damage is normally caused to the seal of the bearing. The damaged seal is unable to keep the grease in and contaminates such as water out .

Lack of grease and contaminants entering the bearing soon allow the bearing to become noisy and fail in a short with in a short amount of time.

This failure is irreversible. It requires the replacement of the brake hub-disk KF155.81U.
