KD457.48/GB/07/2022

KD457.48

Disassembly/ Assembly recommendations

TIMING BELT DIAGRAM FOR KIT KD457.48

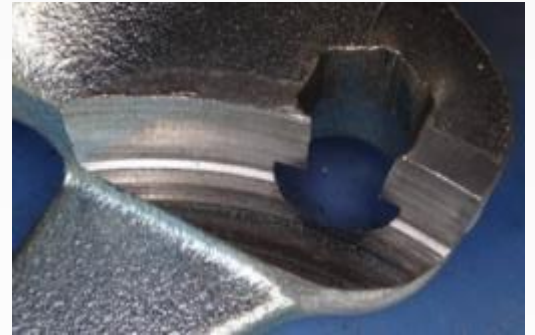
Incorrect installation of GT357.31

This roller requires a particular installation procedure. The retaining bolt must be fully seated against the washer once the specified tightening torque has been applied. If the bolt is tightened incorrectly or not positioned correctly, it will snap, GT357.31 will then rub against GT357.53 causing damage.

Abrasion mark caused by roller contact

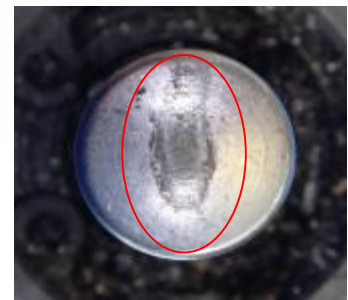
Incorrect tension of GT357.31

- Misalignment of the hole in the shaft of the tensioner and the body of the tensioner indicate a problem with the tension.

Contact mark

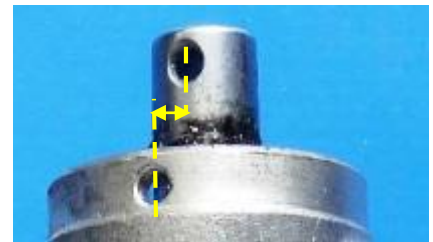
This defect will also cause misalignment and abrasion of the belt.

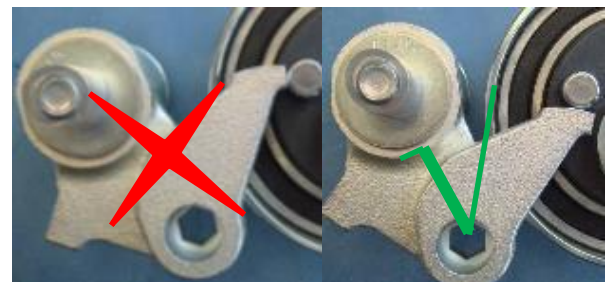
Incorrect positioning of guide GT357.53

- Be careful to position guide GT357.53 correctly with its stop below that of GT357.31. Incorrect installation will lead to the incorrect tensioning of the roller and result in incorrect belt tension.

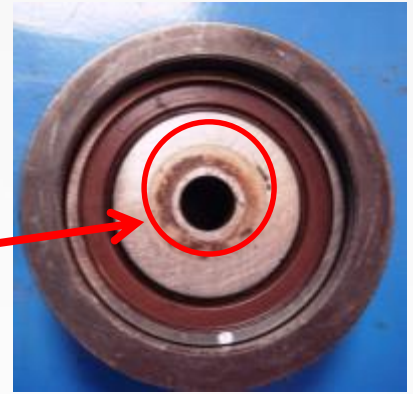
Fracture of the retaining bolt of GE357.30

If the retaining bolt of the roller is not tightened sufficiently or its length is not correct, it will allow the bolt to work in shear fatigue and break.

Fretting marks

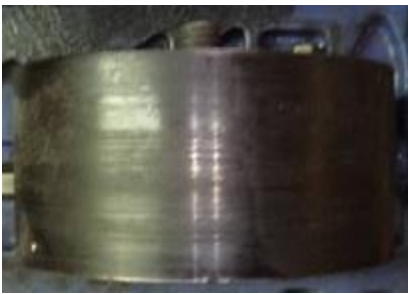
Overheating of GE357.30

Tensioner roller installation specifications (see pages 5 and 6) must be followed carefully. Failure to do so may cause misalignment, loss of belt teeth or even overheating due to rubbing.

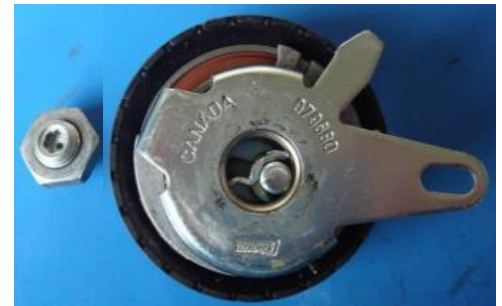
Incorrect installation of GT357.28

Tool OE (3078) is used to tighten the retaining bolt on GT357.28 an Allen key inserted in the tool is used to adjust the eccentric cam that sets the tension applied by the roller. (See page 7) Incorrect installation can cause the roller's shaft to break or result in incorrect belt tension.

Roller GT357.28 with broken shaft

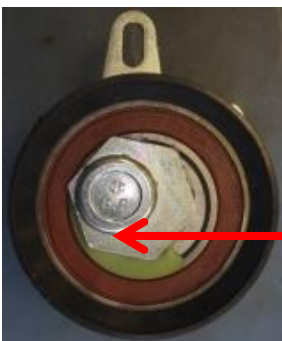
Incorrect tightening of GT357.28

If the retaining bolt has not been tightened correctly using the correct torque setting, the correct tools, or the washer has been left off or incorrectly installed, the lower stop marker will to move backwards and forwards too much and hit the stops this leaves damage on both stops. If the tensioner is correctly adjusted the lower marker will never hit the stops.

The 6 faces underneath GT357.28 are not involved in the operation of the roller. Never tighten or loosen it.

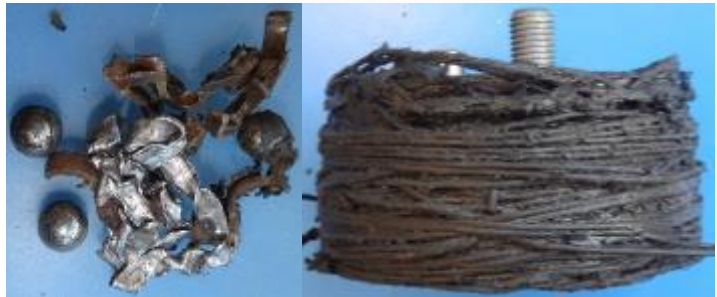
Component seizure

A seized component will cause the belt to overheat, due to friction caused by the belt slipping over the seized component this then causes other components to overheat and break up (bearing grease, rollers, casing).

Consequences of belt slippage

The most common cause of this failure is a water pump seizure. It is recommended that the water pump is changed when a timing belt is replaced.
