# POSSIBLE WHEEL BEARING DEGRADATION

## BRAKE KITS AND SENSORS

WHEEL  
RANGE

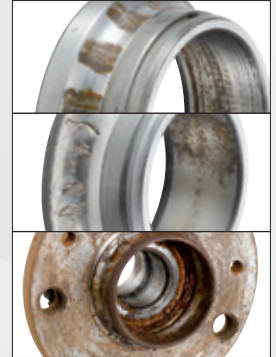
### 3 WATER INGRESS DUE TO A SEALING FAILURE

- Inappropriate use of the vehicle.
- Missing baffle sealing element
- Deterioration of bearing seal during maintenance
- Missing cap or failure to replace cap

- Localized or generalized oxidation of the bearing
- More-or-less extensive reddish or black stains
- Surface attacked by more-or-less deep pitting
- Reproduction of indentations on the raceway

- Do not disassemble a sealed bearing
- Avoid splashing liquids
- Follow the general recommendations associated with the installation
- Replace all parts supplied in the SNR kits

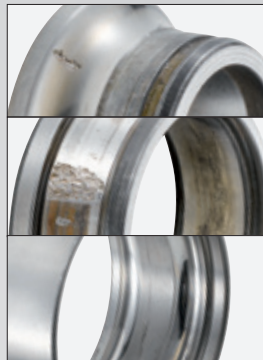
## 4 FATIGUE SPALLING

- Fatigue
- Incorrect installation
- Incorrect geometry of a neighboring part

- Removal of material by flaking along the raceway

- Follow the general recommendations associated with the installation
- Be sure to check the condition of the mating surfaces of the hub or stub axle and of the kingpin (no cracks or wear)

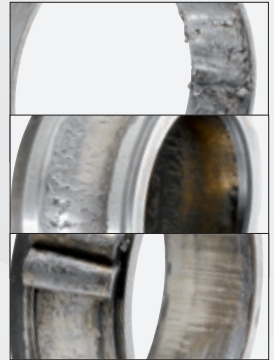
## 5 SEIZING / OVERHEATING / LUBRICATION FAILURES

- Lack of lubrication or inappropriate lubrication
- Micro-welds between the bearing components
- “Mixed” grease following ingress of contaminants

- Shallow metal pullouts on the bearing raceway
- Welding of the bearing components
- Discoloration of components

- Monitor for abnormal grease leakage
- Follow the general recommendations associated with the installation
- Make sure bearing elements have correct lubrication

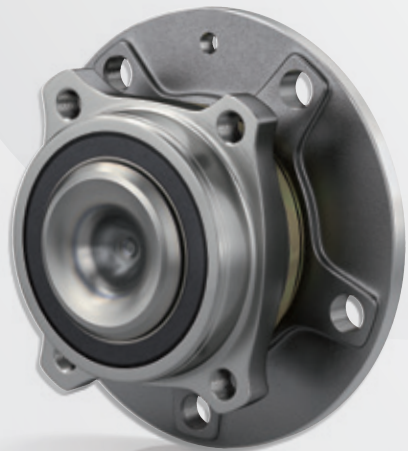
## 10 ABS MALFUNCTIONS

- Computer error
- Sensor error
- Connector problem
- Encoder damage
- Bearing installed backwards

- ABS® indicator on the instrument panel lights up or remains lit

- Verify cleanliness of sensor and encoder
- Never bring the sensor or the encoder near a magnetic source
- Check the condition of the encoder seal using the SNR tester card

- Take care not to damage the sensor (tearing off), replace it if that happens
- Position the bearing with the encoder facing the sensor (inboard side of the vehicle)
